Manhole Inspection Summary

Manhole # S25GG1020MH

Insp Date: **8/14/07 10:40 AM**

Location Address: **4030 FALLS RD**

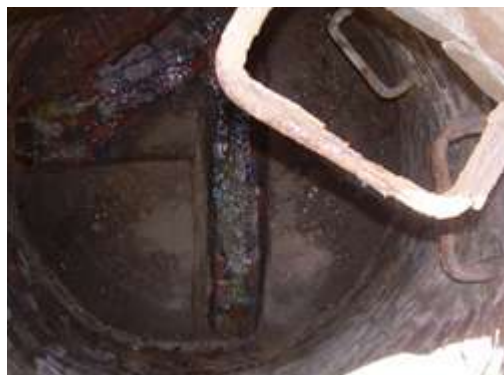
Top View

☒ **Debris** (not Condition related)

☒ **Corroded**

Corroded steps. Bench and Channel debris.

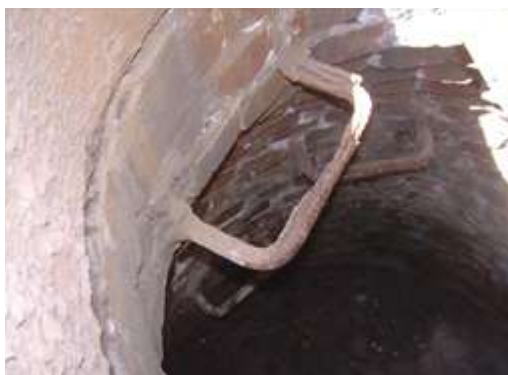
Defect

☒ **Leaks**

Infiltration: ☐ None ☒ **Joint** ☐ Cracks ☐ Mortar ☐ Roots ☒ **Wall**

Infiltration: ☐ None ☐ Joint ☐ Cracks ☒ **Mortar** ☐ Roots ☒ **Wall**

Frame leaks. Adjustment and Barrel infiltration.

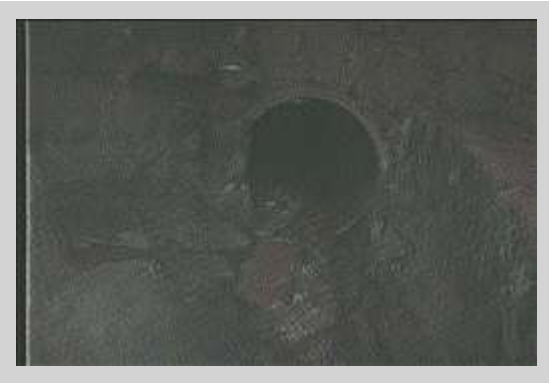
8 in. Circular Gravity Sewer Pipe Out @ 12 O'Clock

Infiltration: **None** Pipe Seal Cond: **Cracked**

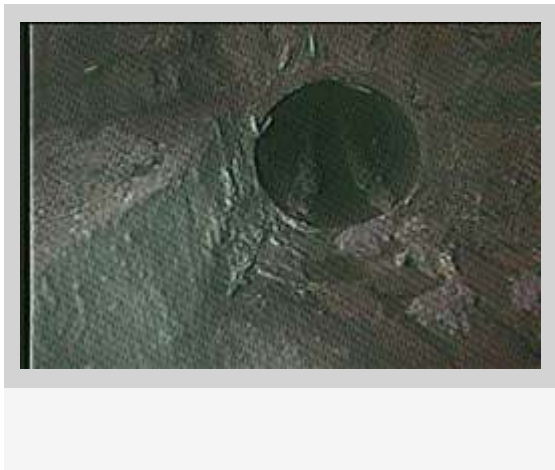
8 in. Circular Gravity Sewer
Pipe In @ 9 O'Clock

Deposits: ☐ None ☐ Mud ☐ Sludge ☐ Debris ☒ **Grease**

Silt Depth: **0** (in.) Deposits Extent: **Light**
